Cutler Ridge Park Pool Assessment

Stantec Project No. 215617462

July 2022

Town of Cutler Bay**Aquatic Facility Condition Assessment****For****Cutler Ridge Park
Pool and Mechanical Equipment**

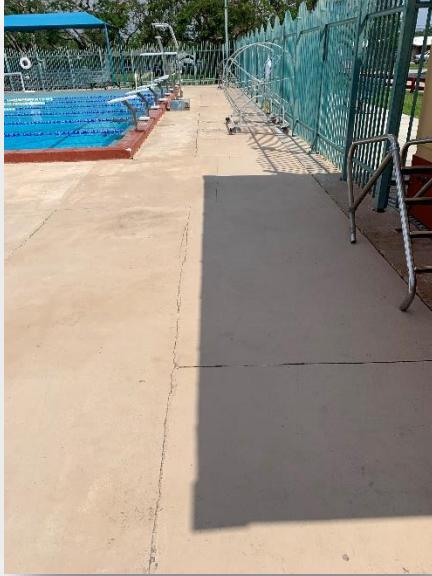
Reflection cracks in pool deck

Pool deck must be replaced

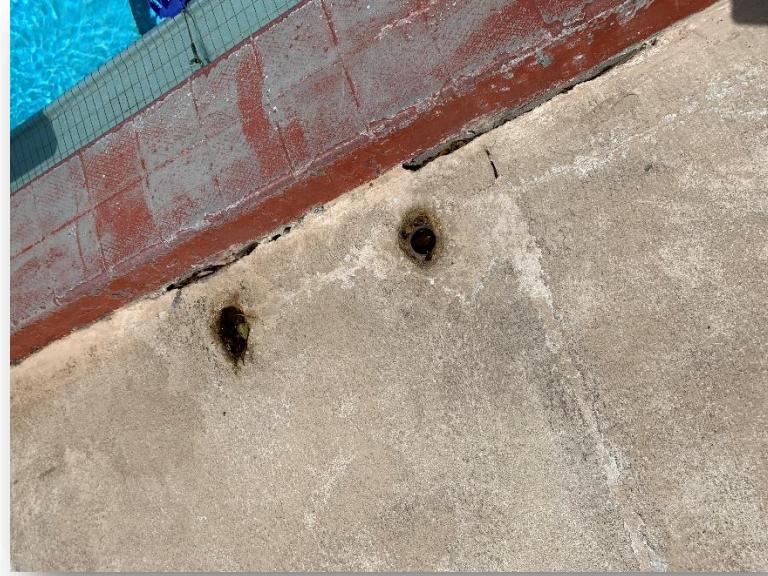
Old ladder inserts deteriorating in deck

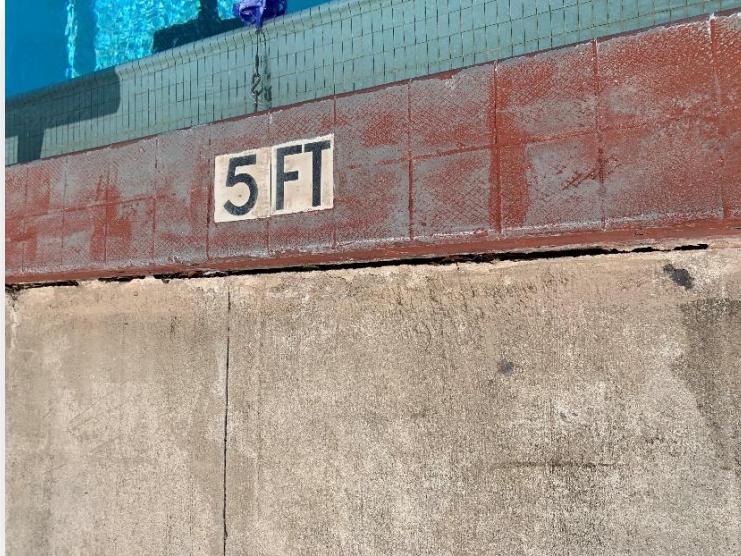
Settlement and loss of expansion joint material on east side

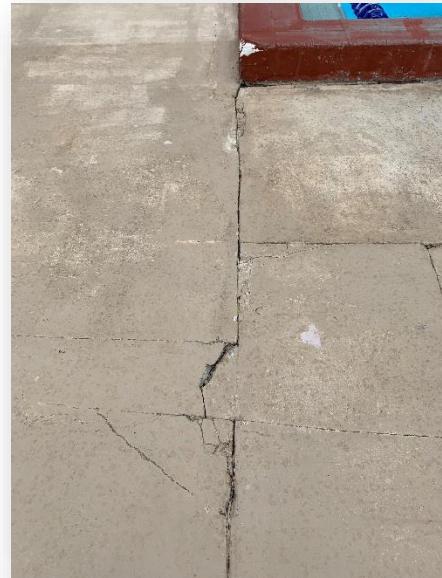
Cracking and spalls in pool deck on east side

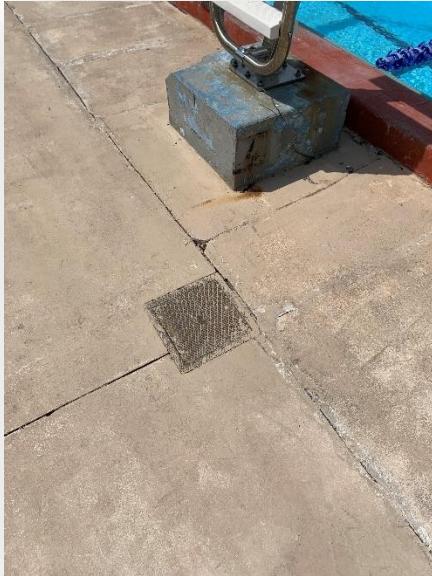
Distress and cracks around utility lid

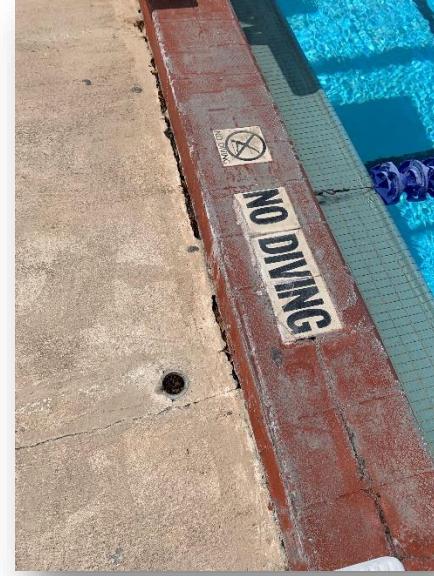
Distress and settlement behind gutter coping

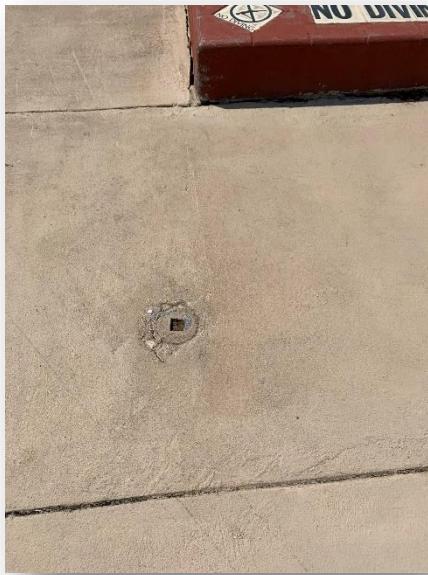
Spalling around cleanout in deck

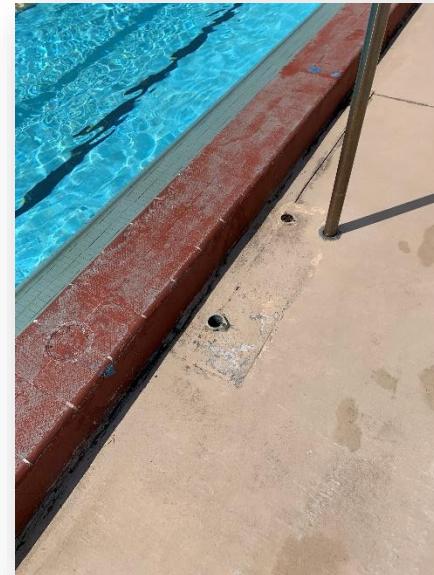
Old ladder inserts sticking up from deck

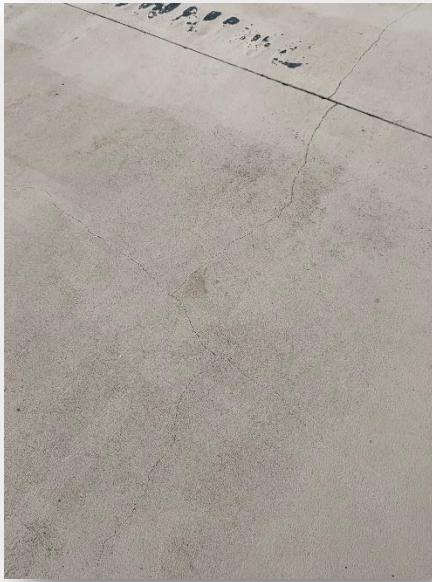
Shrinkage cracking in deck on north side

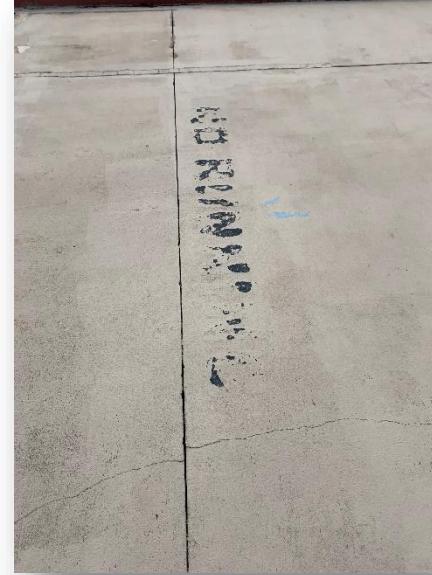
Cracking and distress in joint

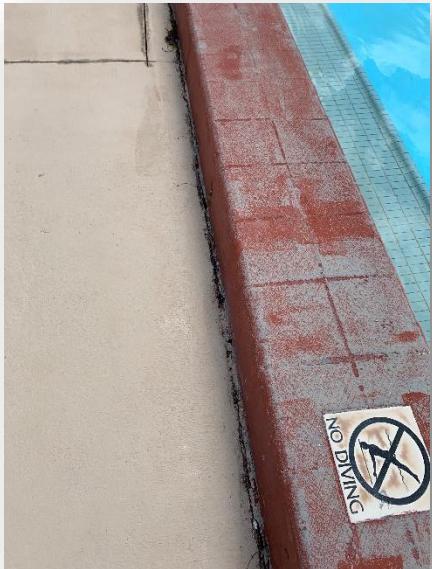
Settlement and loss of expansion joint material on north side

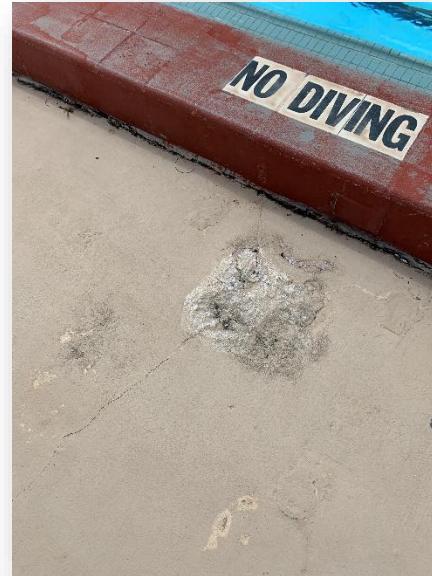
Concrete spall on north side

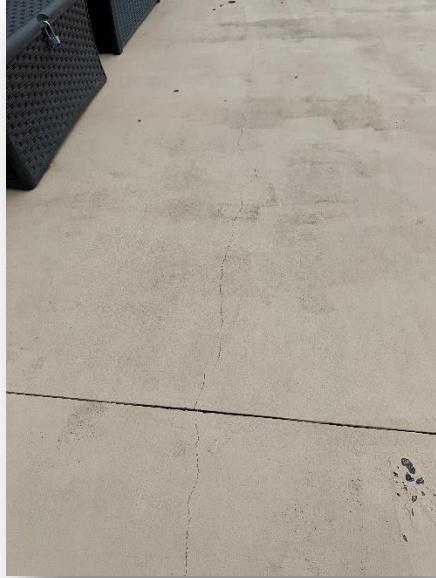
Cracking in deck near NW corner

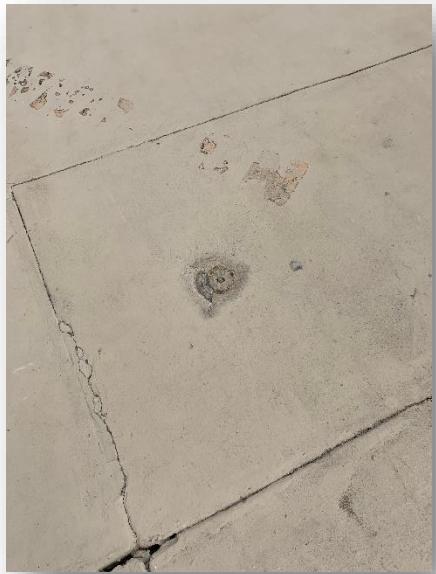
Cracking and distress around clean out in SW corner

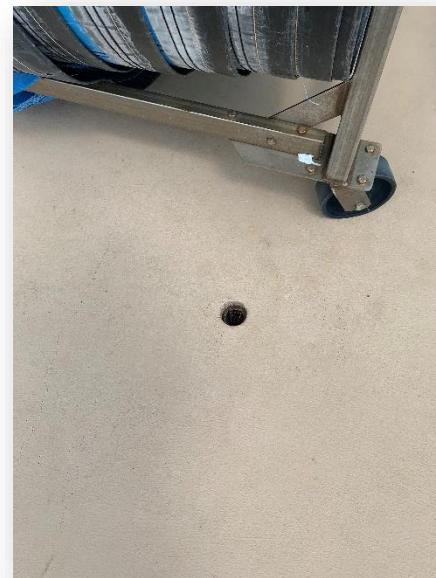
Miscellaneous hole in deck along north side

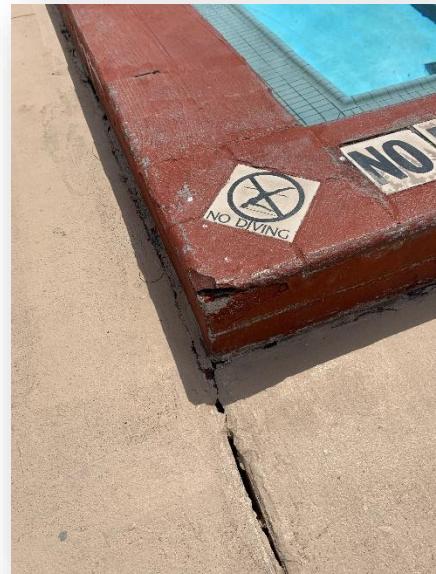
Damage to gutter coping and joint on southeast corner

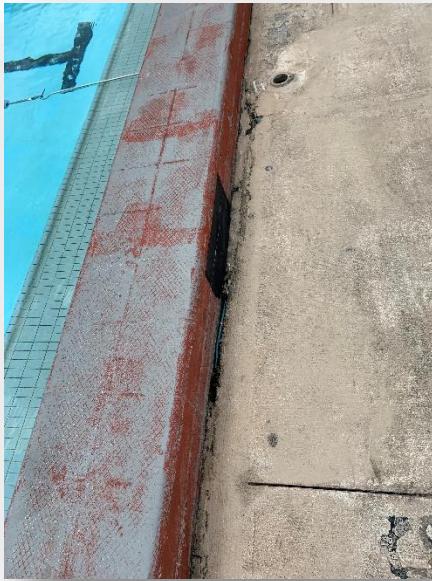
Loss of expansion joint material and exposed

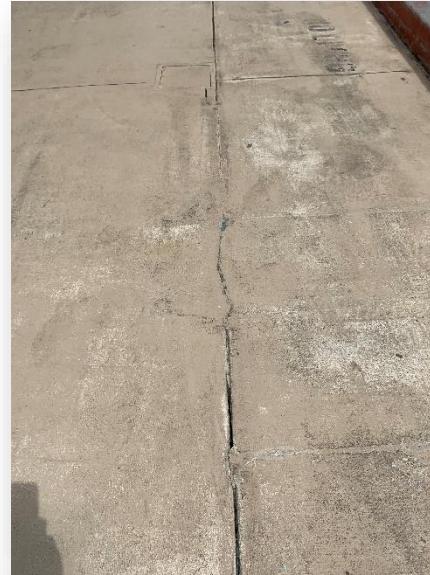
Reflection cracking on south side deck

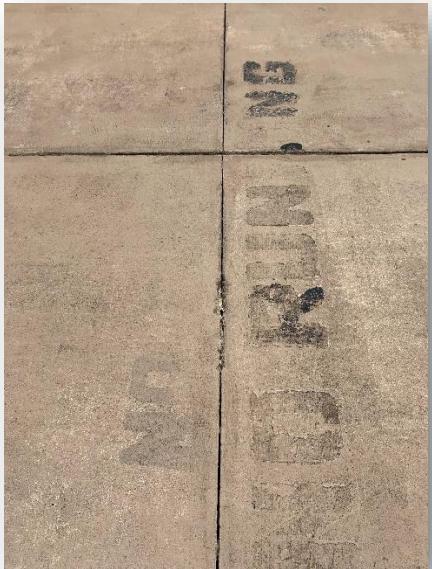
Lettering on deck fading and worn away

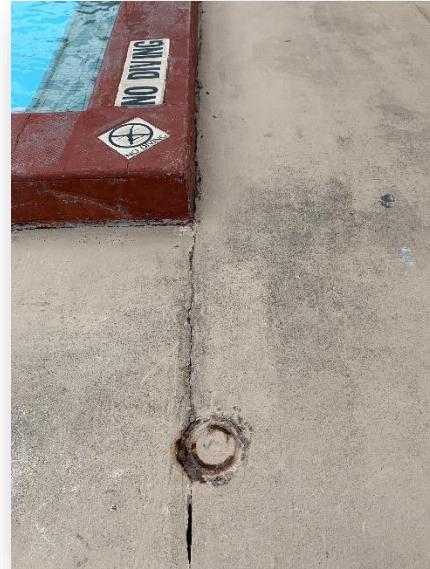
Old metal pipe embed corroding in deck at SW corner

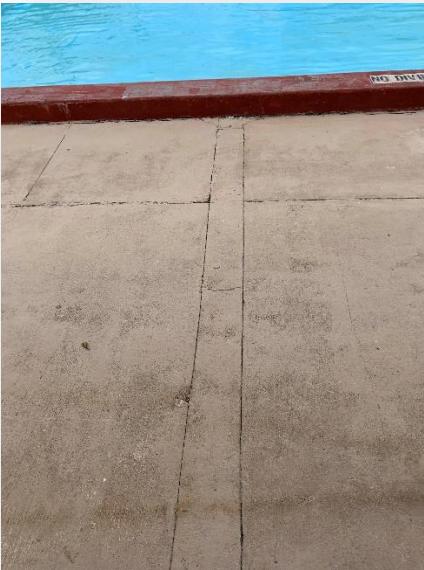
Crack in concrete repair

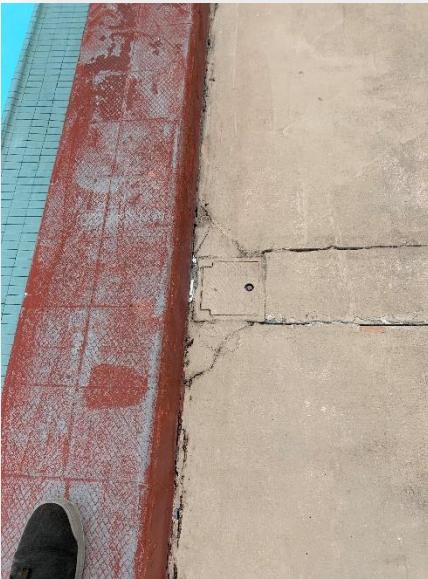
Distress and cracking at utility box on south

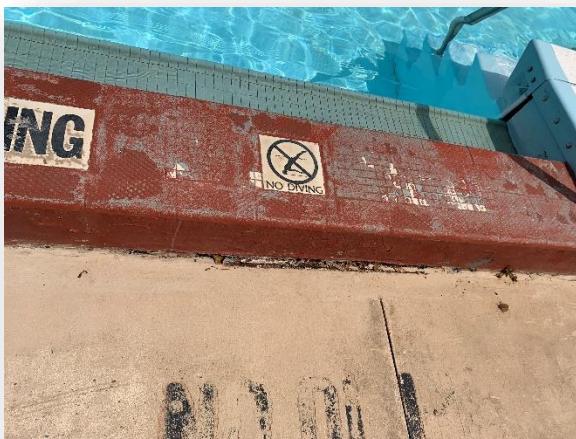
Settlement and deterioration of joint behind coping

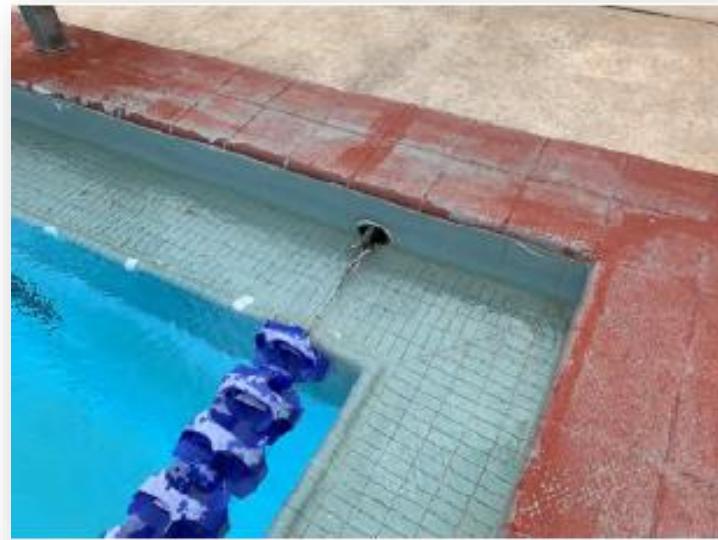
Gutter showing missing tiles

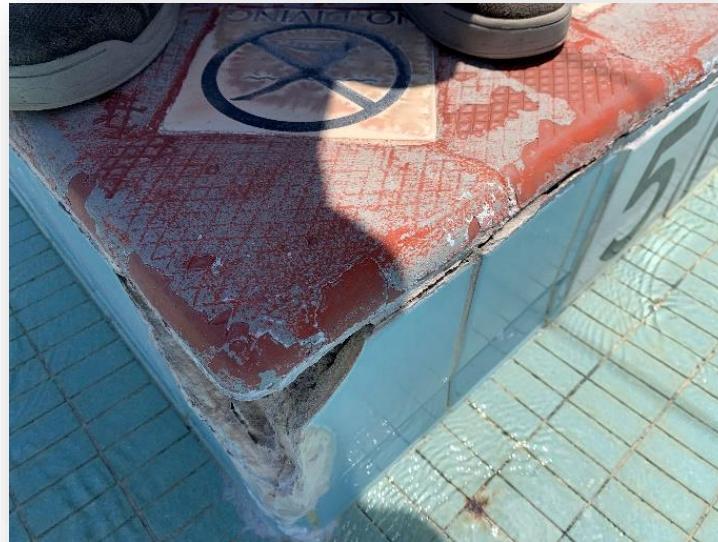
Damage and deterioration to pool and gutter corner

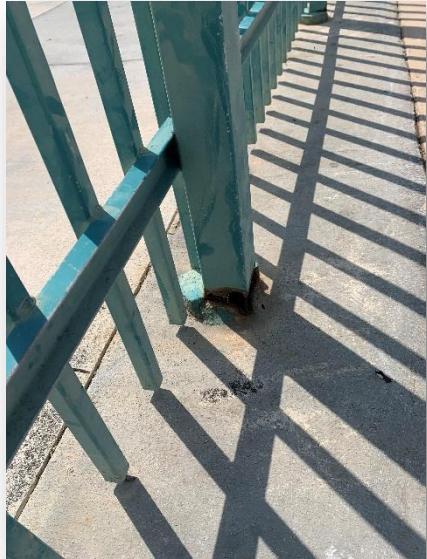
Corrosion of fence post on east side

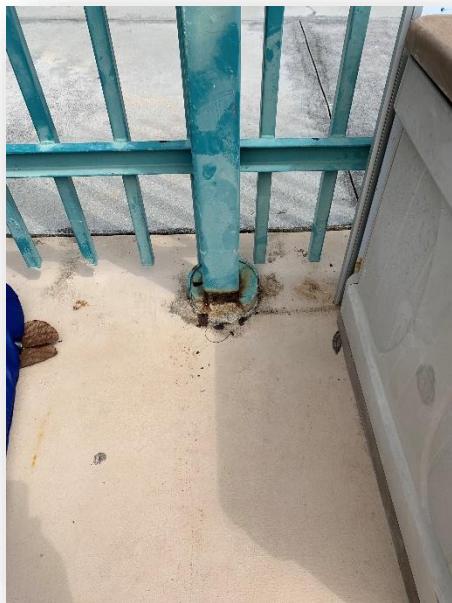
Corrosion of fence post on west side

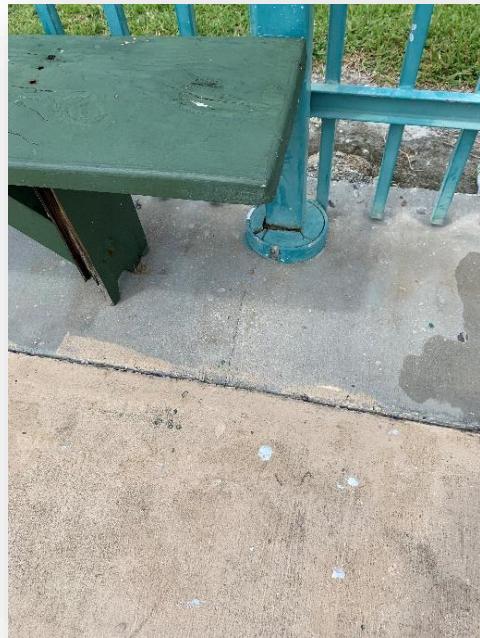
Crack in deck and corrosion of fence on west

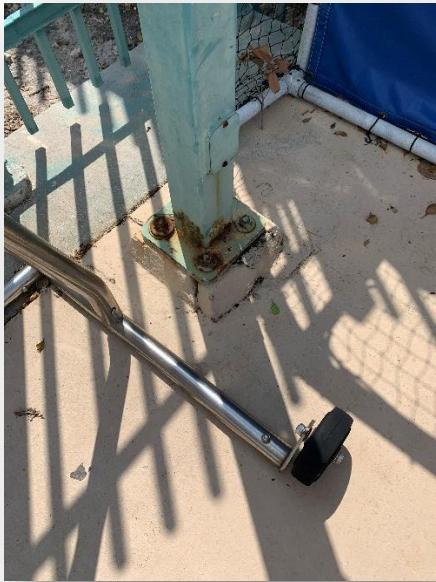
Light pole base showing corrosion in SE corner

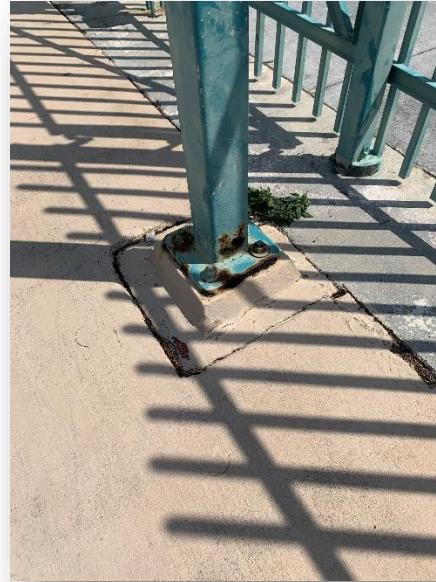
Light pole base showing corrosion in NE corner

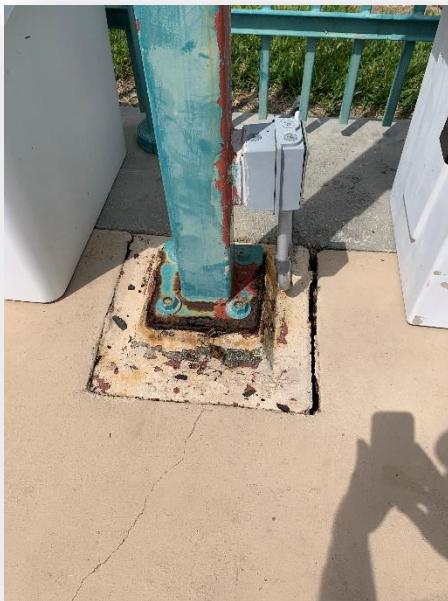
Light pole base showing corrosion in NW corner

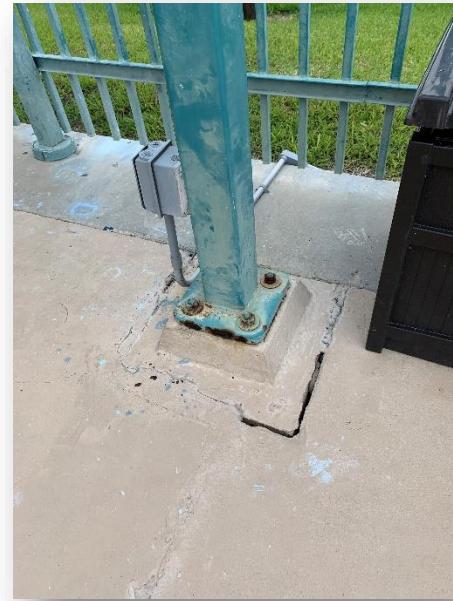
Light pole base showing corrosion in SW corner

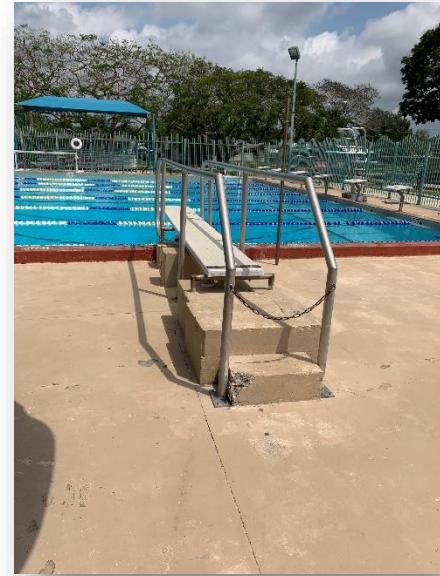
Spalls in steps of springboard

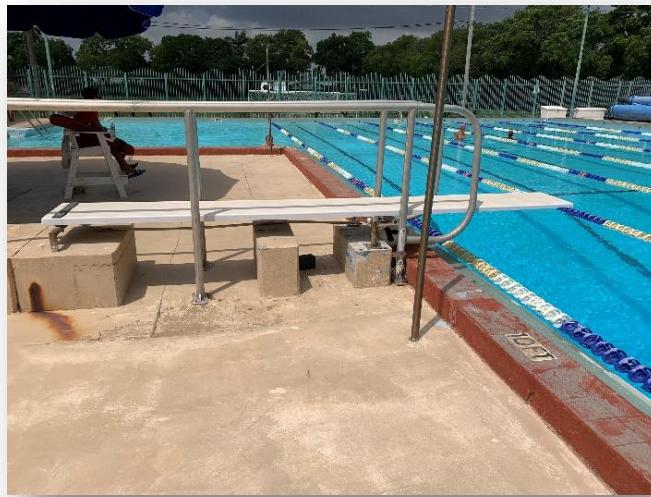
Cracks, rust, and corrosion on dive pedestals

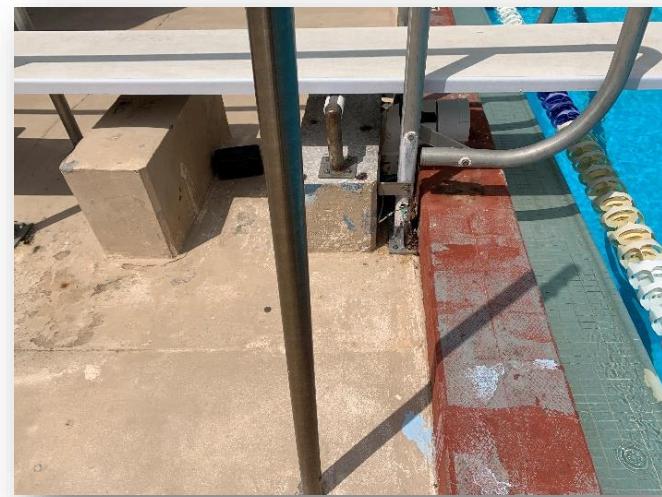
Corrosion and distress on springboard supports

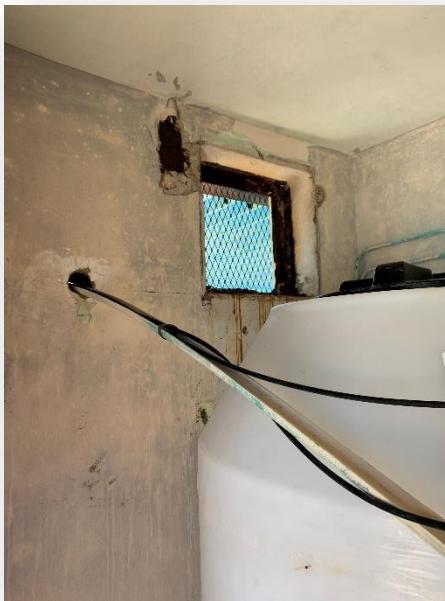
Corroded vent screen and metal in containment room

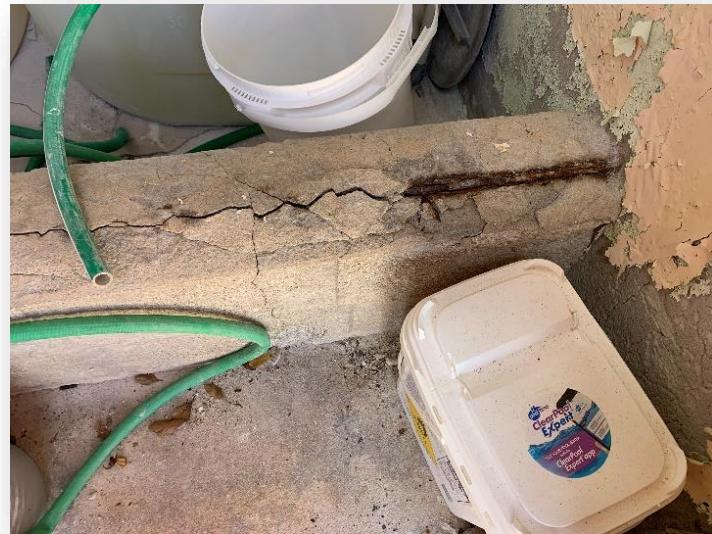
Cracked and corroded curb in containment room

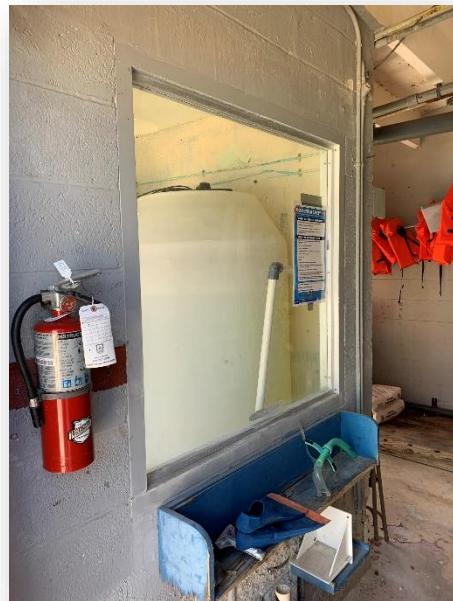
Distressed masonry block on outside of containment room

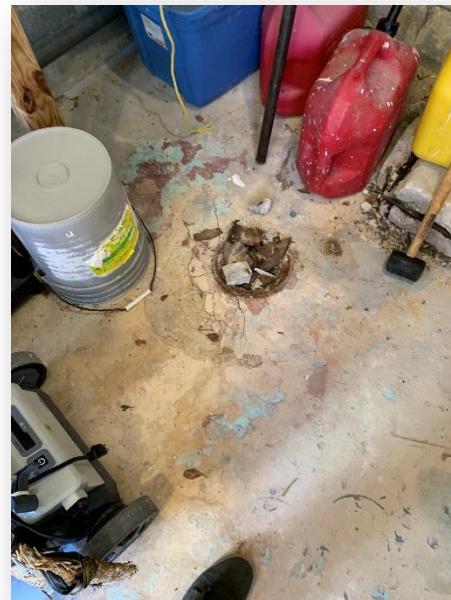
Floor drain corroded and cracked

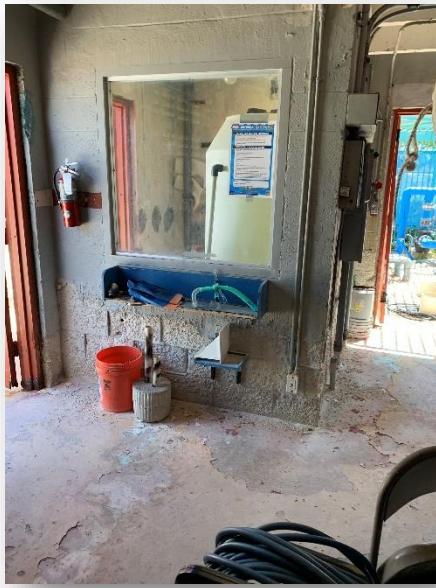
Containment room showing masonry block damage and floor delamination

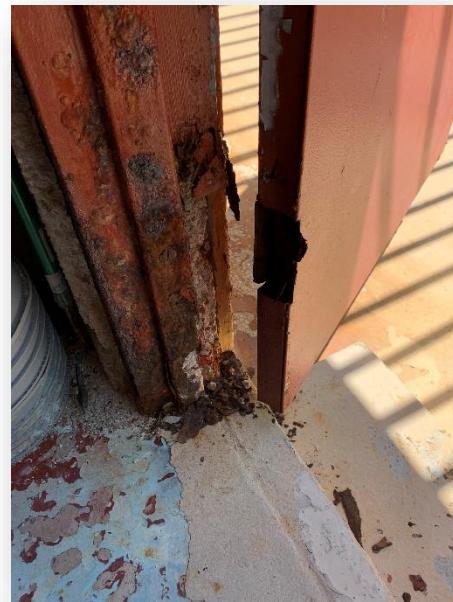
Storage room door showing severe corrosion

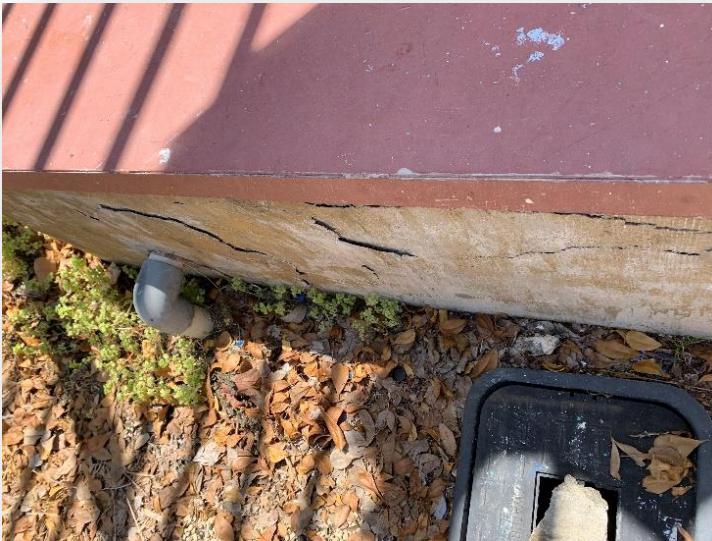
Concrete spalls on east side of collector tank

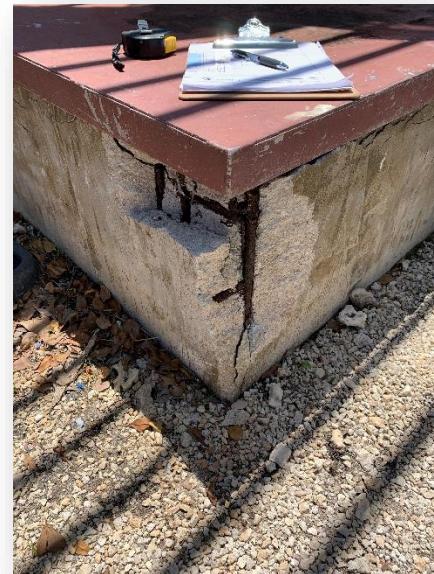
Collector tank damage at NW corner

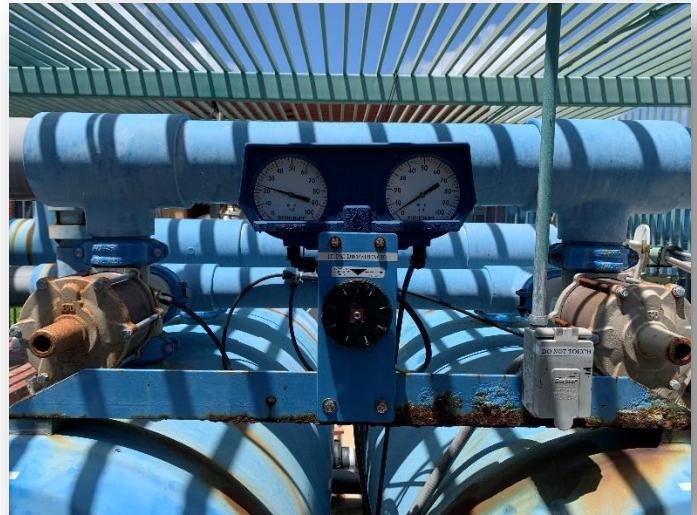
Filter controls showing corrosion on brackets

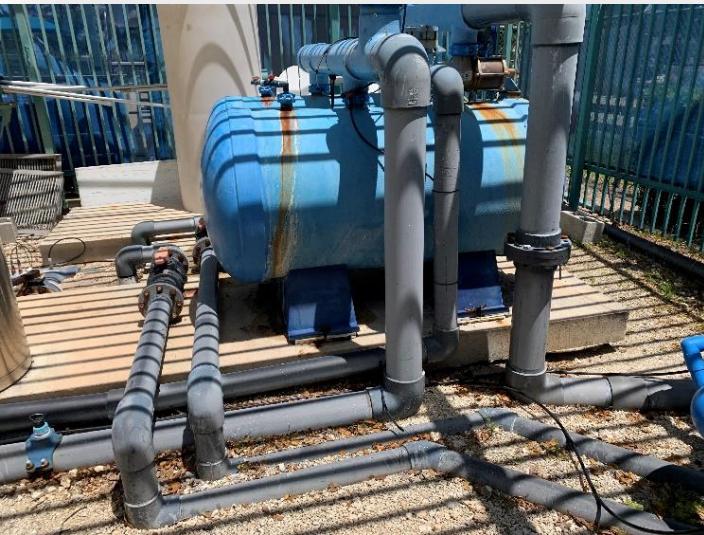
Filter piping—note rust on tank from blow off

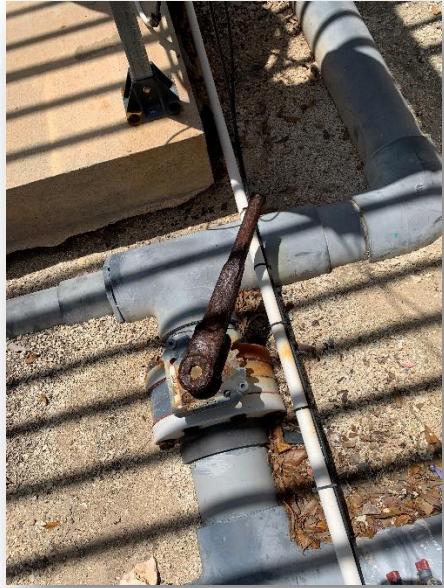
Master valve showing corrosion
