Town of Cutler Bay Stormwater Master Plan

Prepared for:
The Town of Cutler Bay
043145000
March 2008
©Kimley-Horn and Associates, Inc.

EXECUTIVE SUMMARY

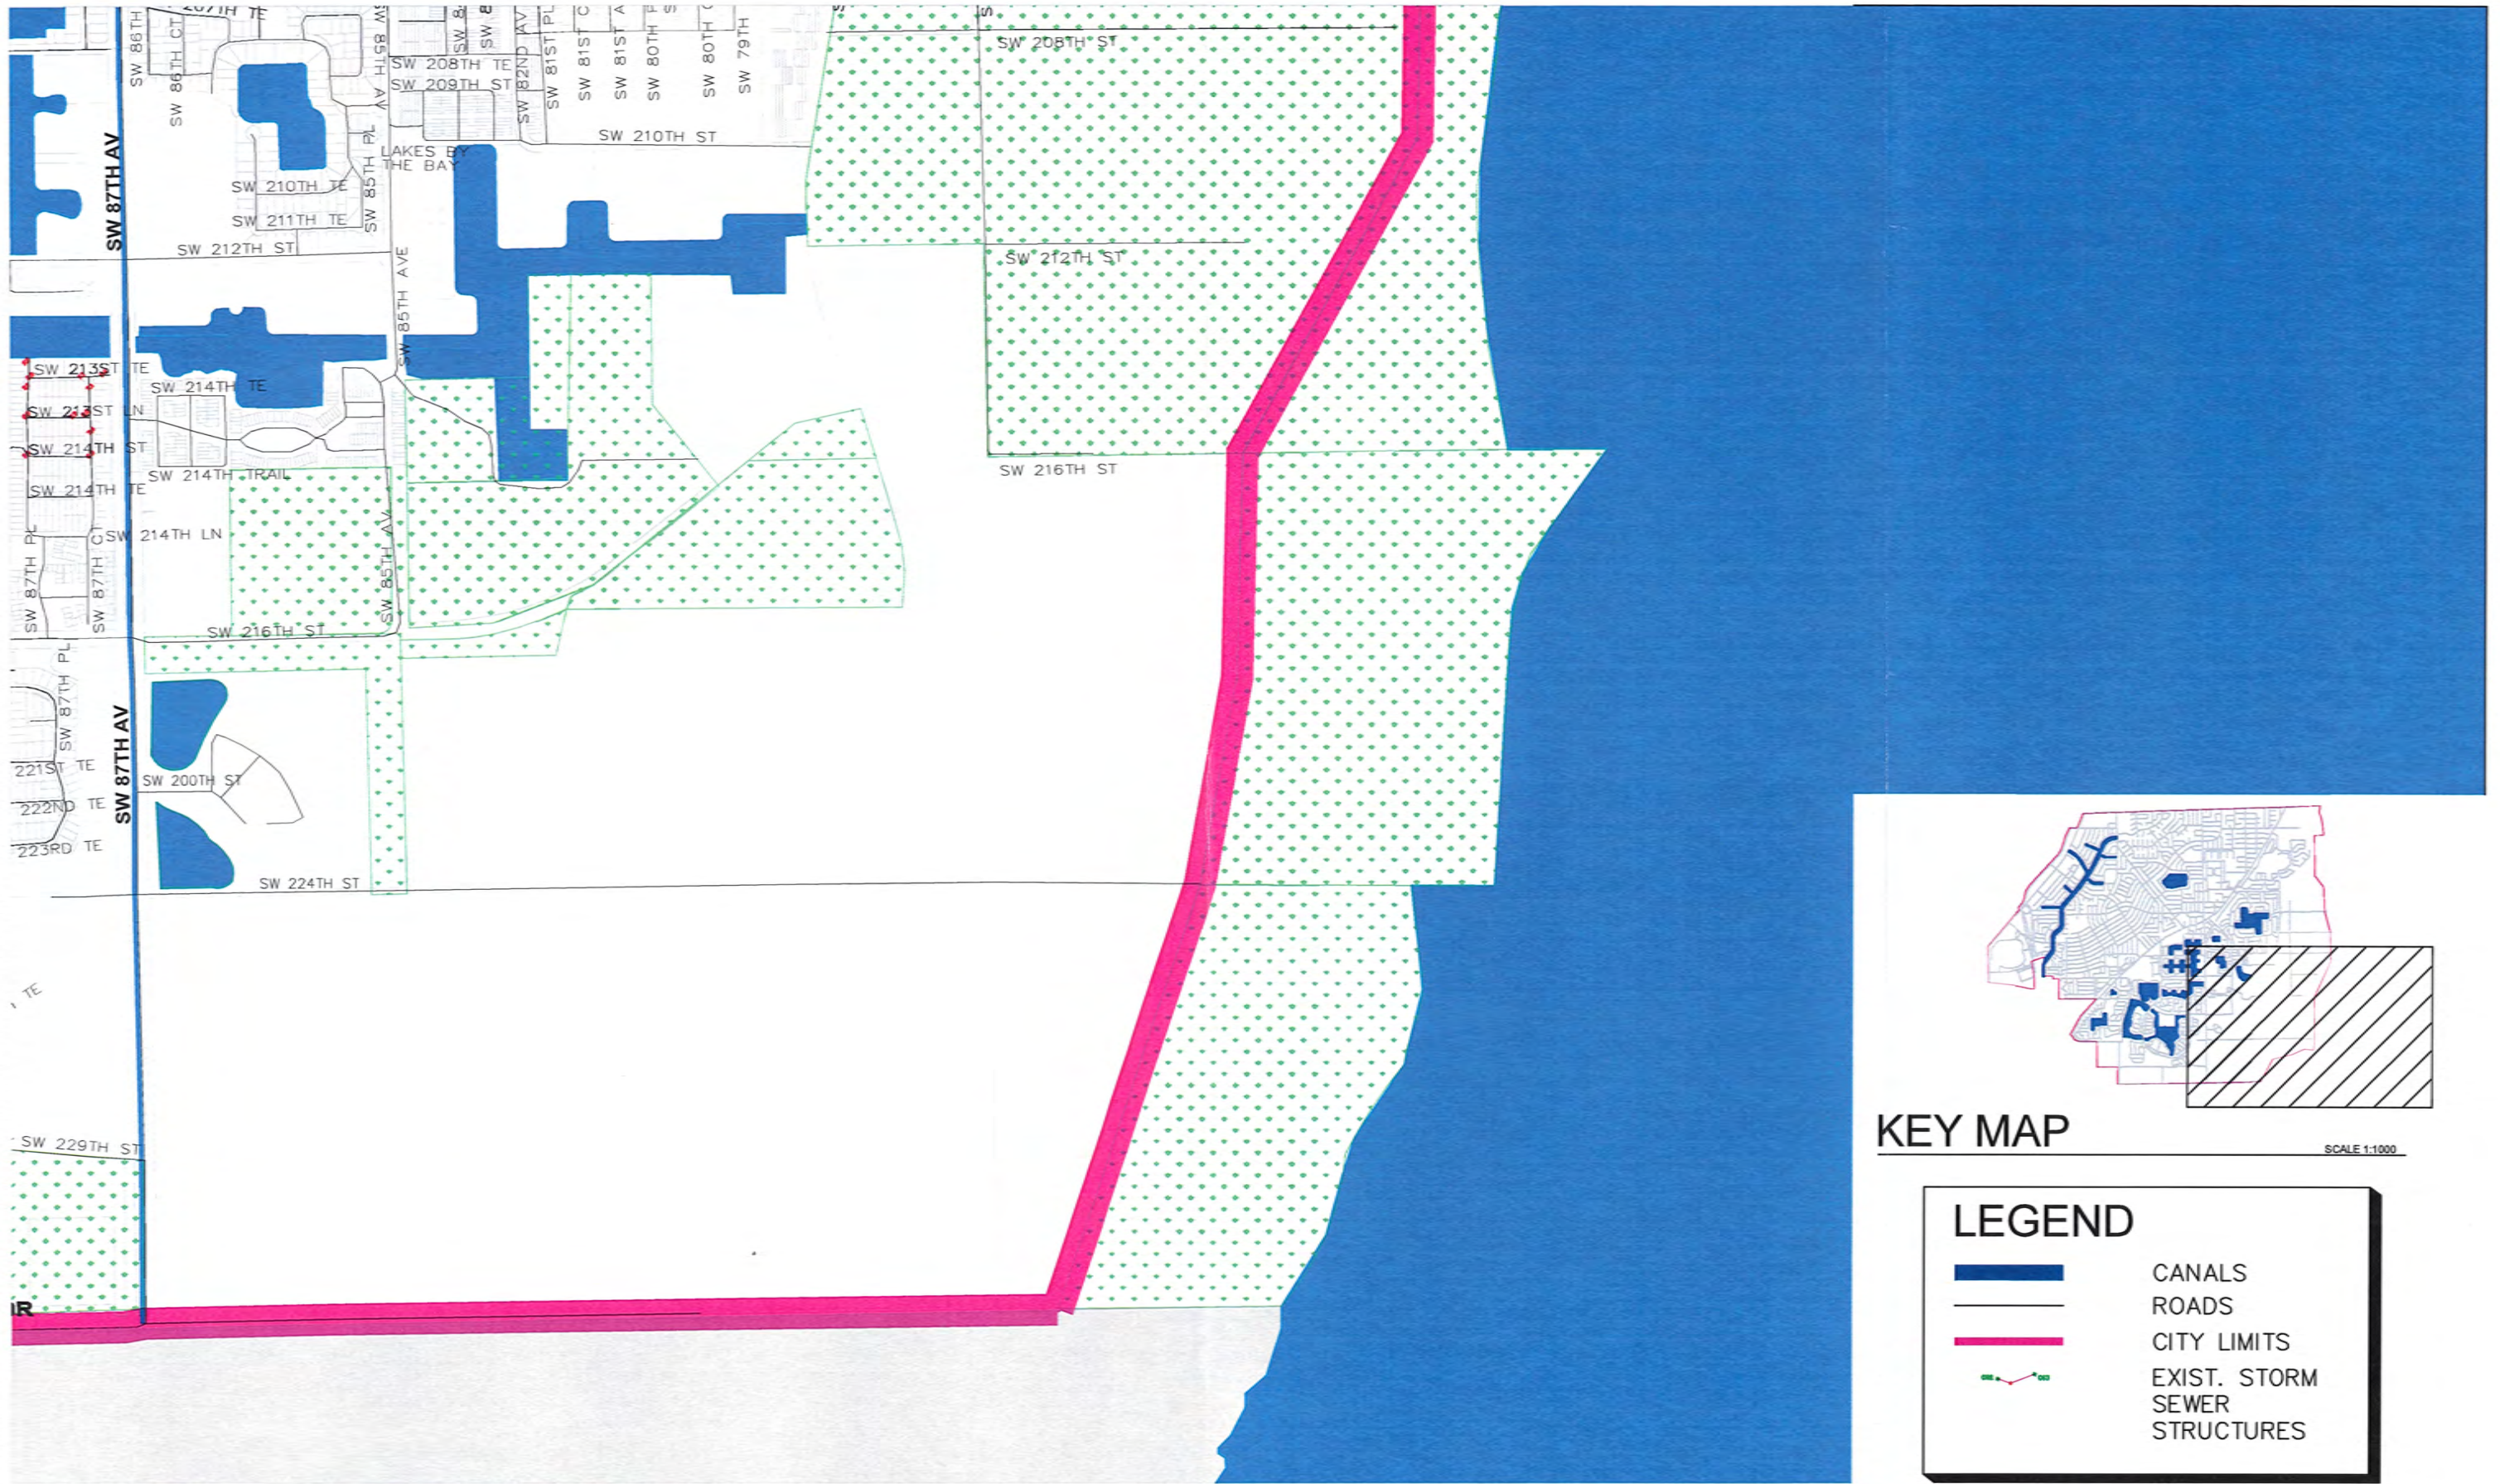
FIGURE 9

Drawing name: H:\043 jobs\043145000-Cutler Bay Stormwater MP\CADD\CIVIL\CONCEPT\FIG 9 DRAINAGE STRUCTURES.dwg FIG 9 SW Master Plan SE Feb 28, 2008 5:32pm by: jairo.castro

A disc containing the AutoCAD mapping information and the drainage structure data spreadsheets is included in Appendix B. *Figures 6 through 9* illustrate the drainage structure locations.

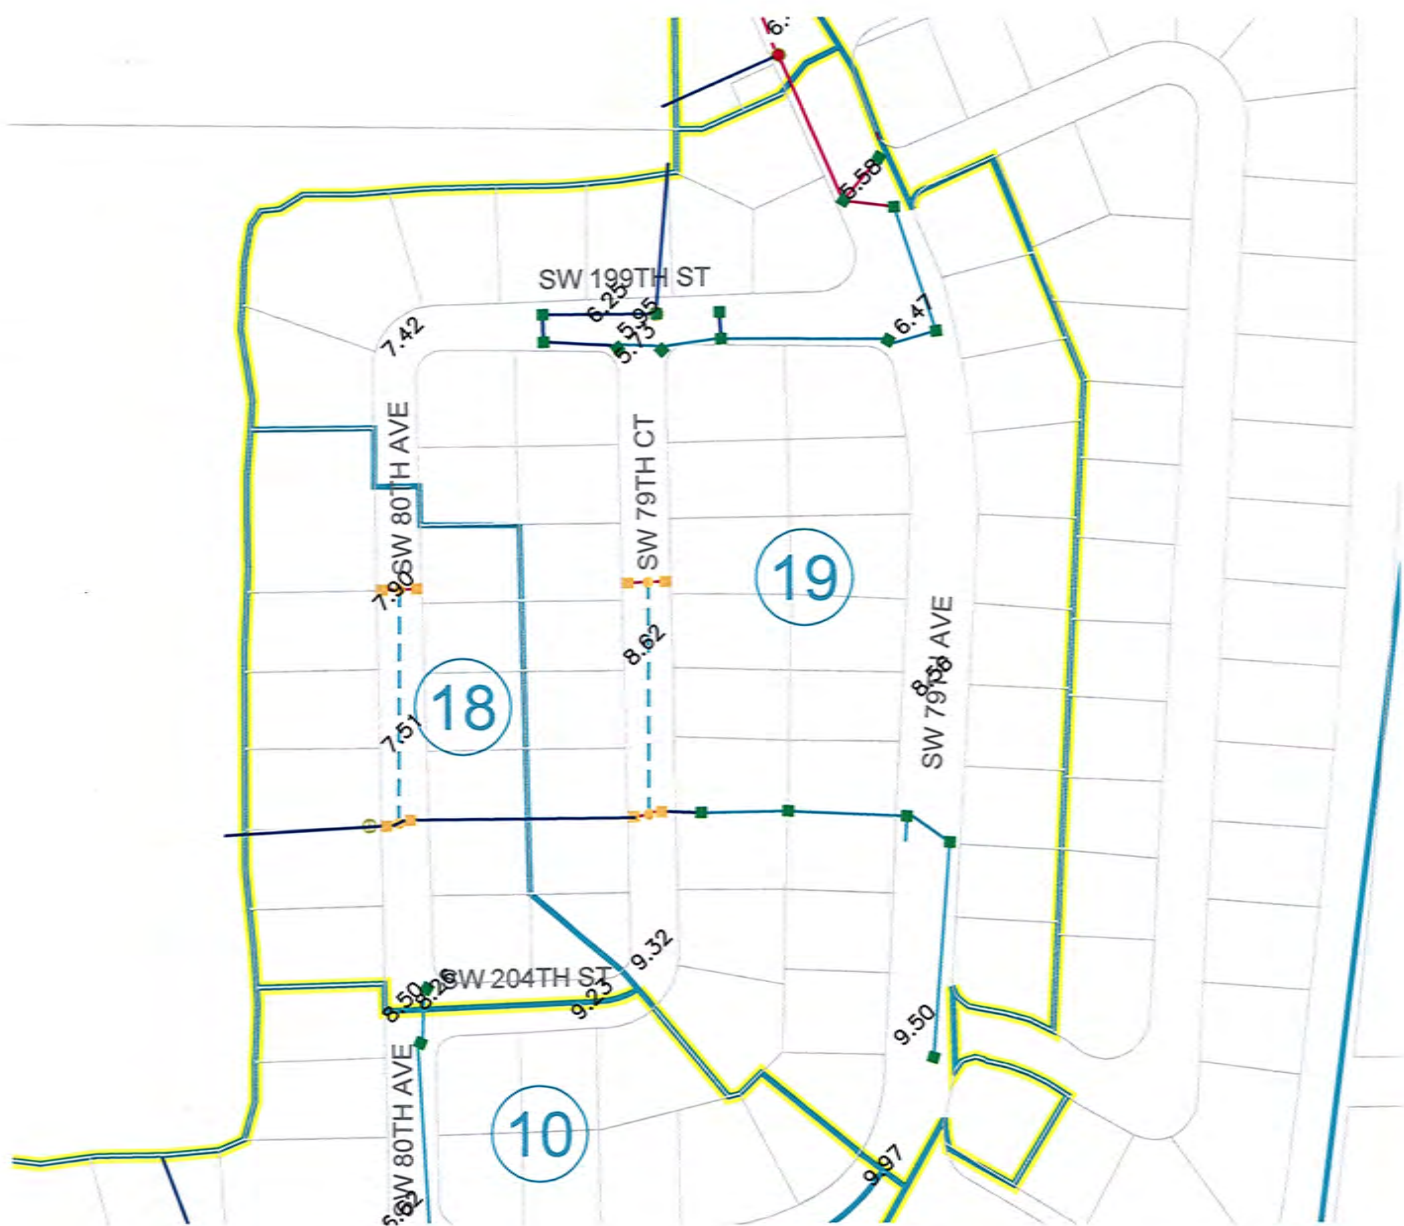
SUMMARY OF PROPOSED MODIFICATIONS

- REPLACE 2 CB WITH WEIR STRUCTURES
- REPLACE 3 EXISTING CATCH BASINS
- ADD 4 MANHOLES
- ADD 60 LF 18" HDPE PIPE
- ADD 210 LF FRENCH DRAIN

- AREA 18 PROPOSED MODIFICATIONS**
- REPLACE 1 C.B. WITH WEIR STRUCTURE
 - REPLACE 1 EXIST. C.B.
 - ADD 2 MANHOLES
 - ADD 20 LF OF 18" PIPE
 - ADD 115 LF OF FRENCH DRAIN

- AREA 19 PROPOSED MODIFICATIONS**
- REPLACE 1 C.B. WITH WEIR STRUCTURE
 - REPLACE 2 EXIST. C.B.
 - ADD 2 MANHOLES
 - ADD 40 LF OF 18" PIPE
 - ADD 95 LF OF FRENCH DRAIN
