Cutler Ridge Park Pool Assessment

Stantec Project No. 215617462

July 2022

Town of Cutler Bay**Aquatic Facility Condition Assessment****For****Cutler Ridge Park
Pool and Mechanical Equipment**

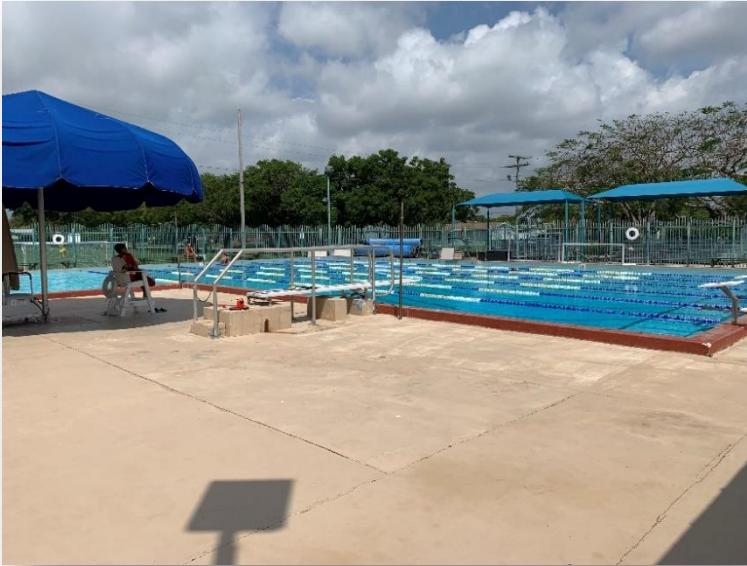
Pool looking SW from NE corner

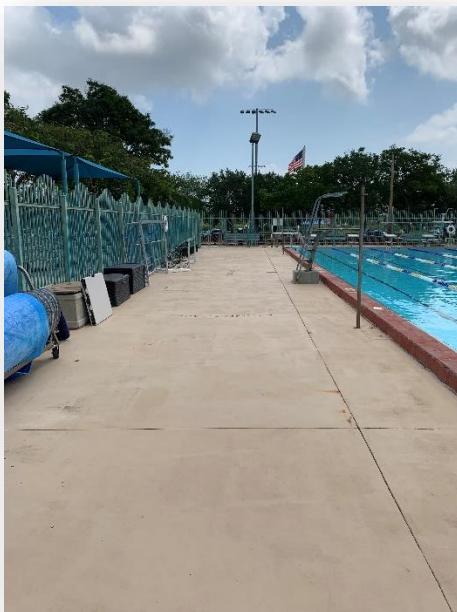
Pool looking east from NW corner

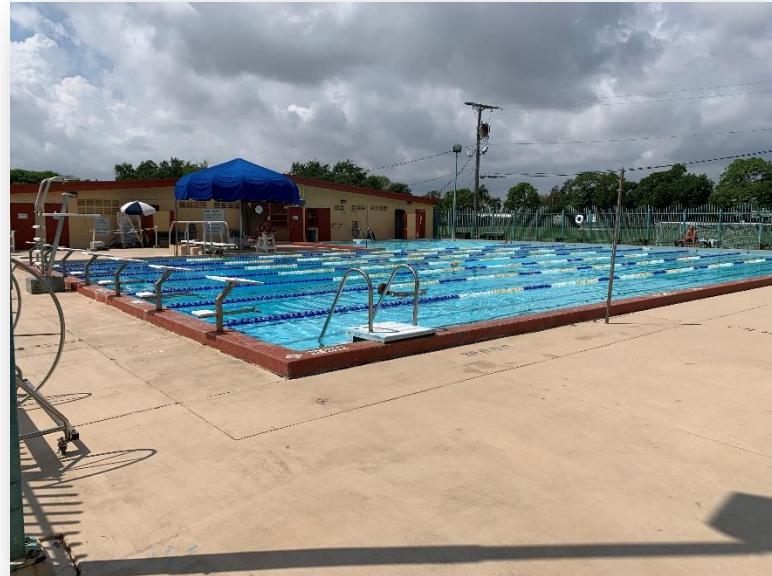
Pool looking North from SE corner

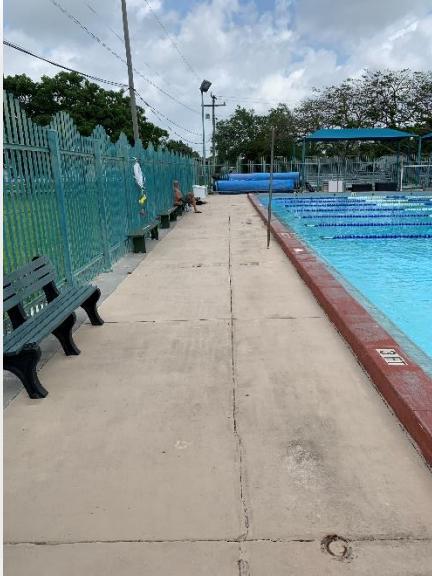
Pool looking north from SW corner

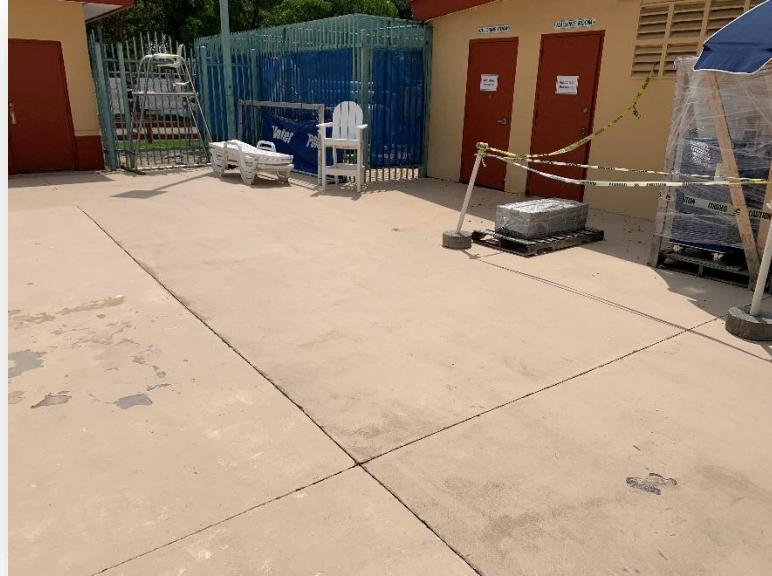
Pool deck at SE corner

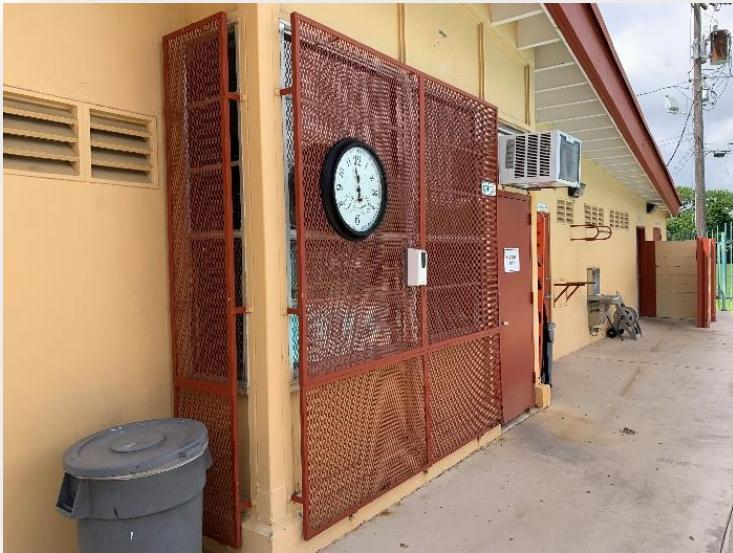
Pool building facing pool

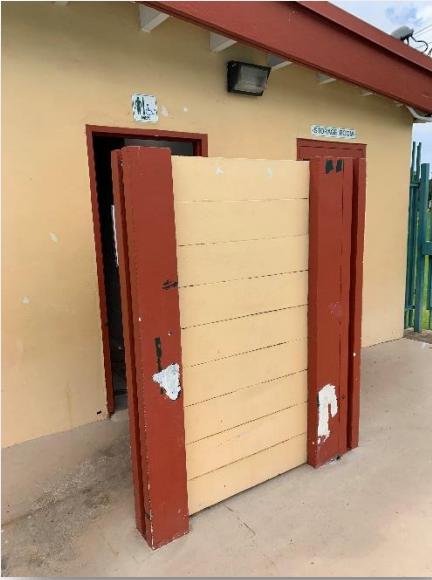
Men's restroom privacy screen

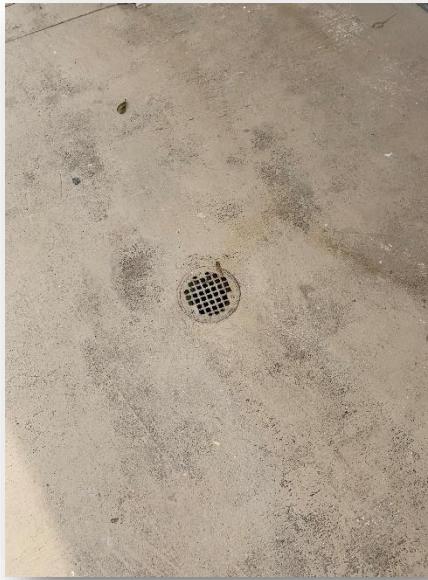
Typical deck drain

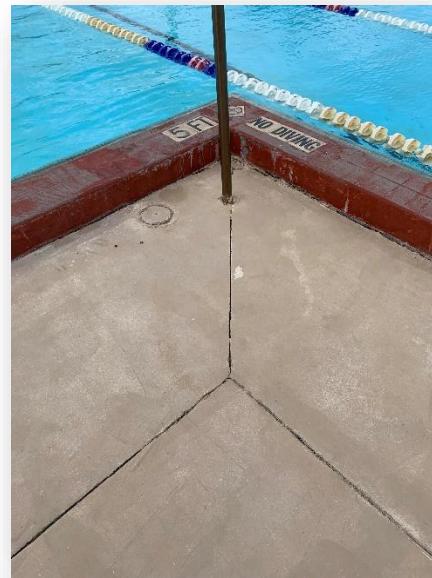
Settlement of deck behind coping on south

Pool deck must be replaced

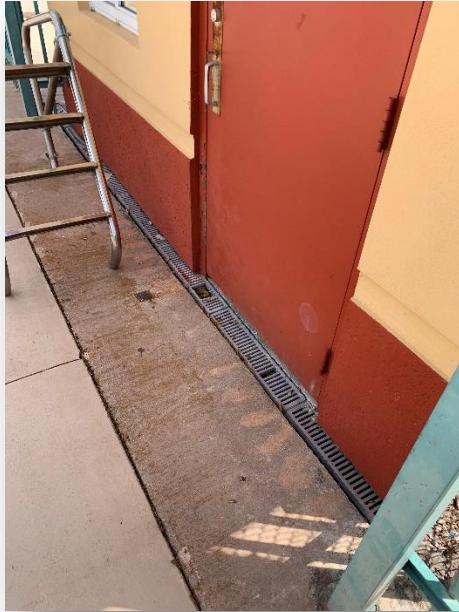
Deck drain settlement and separation at concession building

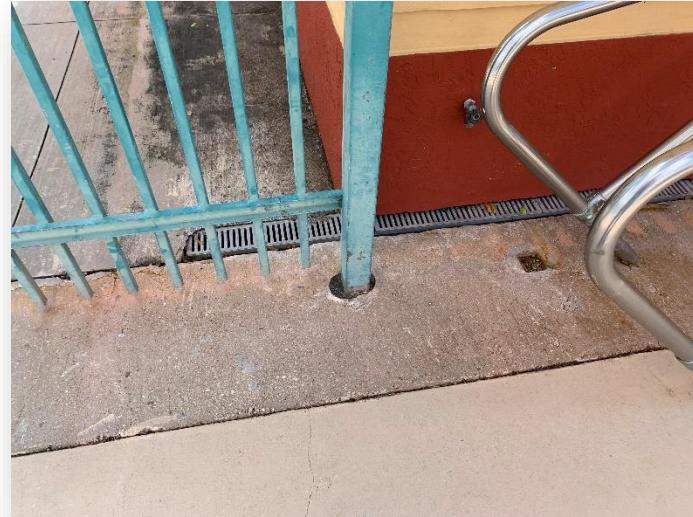
Deck drain settlement and separation at concession building

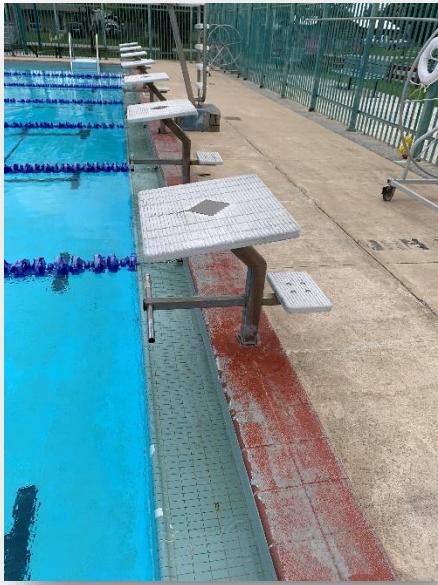
Swim start platforms on east side

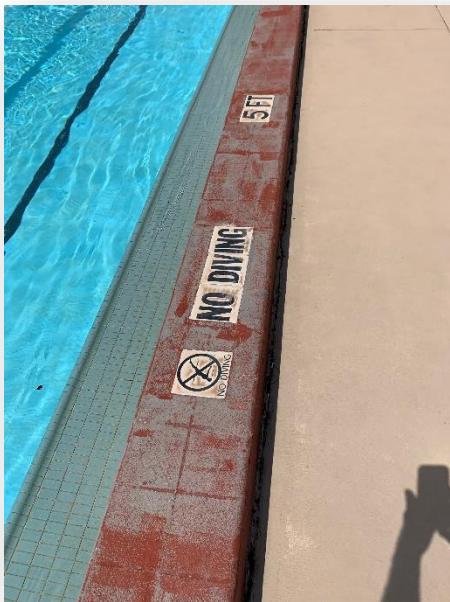
Depth and warning tiles in gutter coping

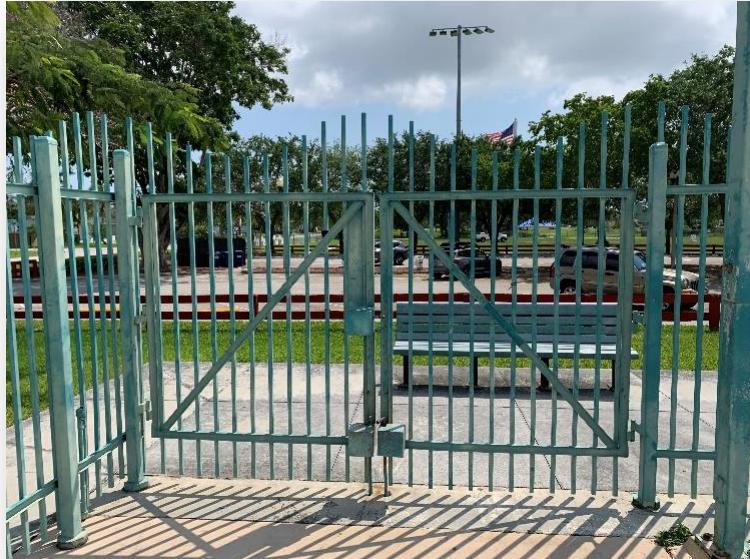
Gate in NE corner

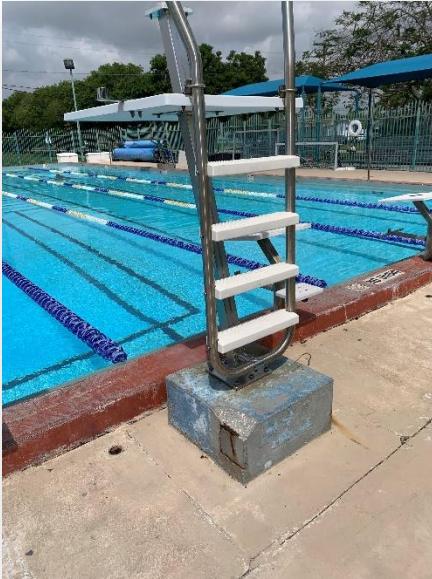
Lifeguard stand minus chair on east side

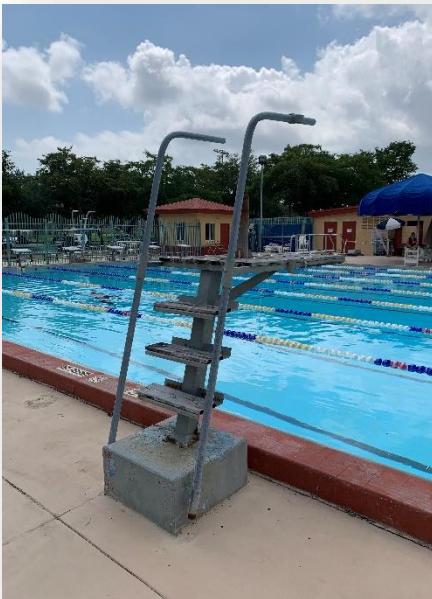
Lifeguard stand on north side minus chair

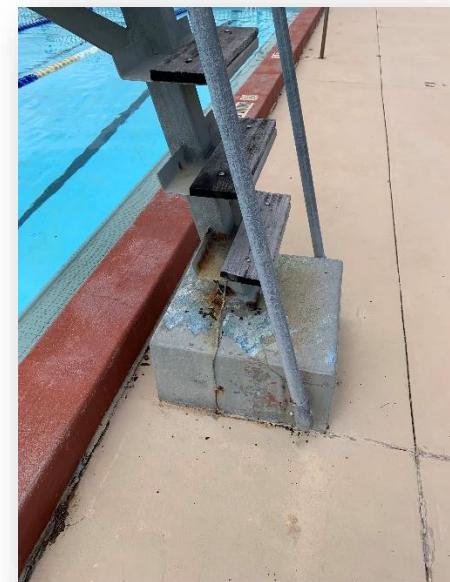
Lifeguard stand on north side showing distress and exposed wire

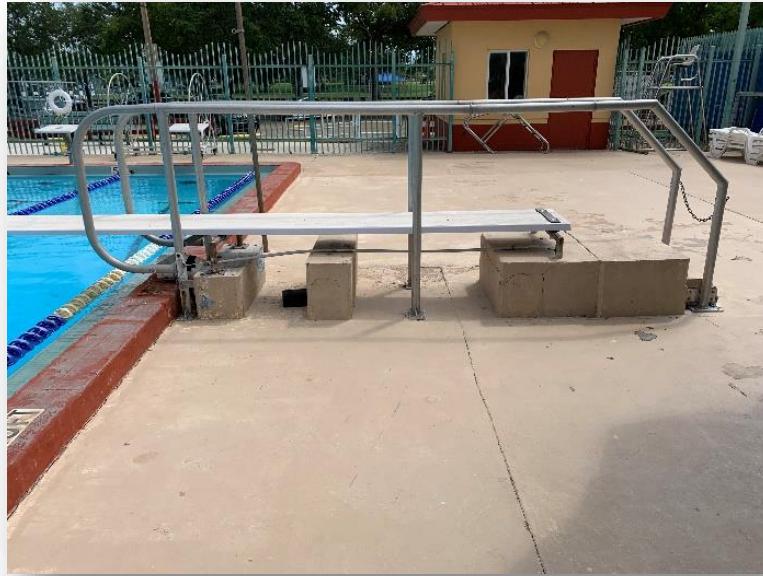
Dive pedestals and springboard

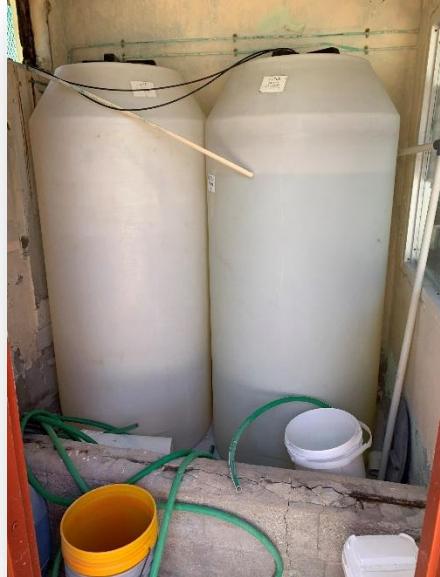
Chlorine tanks in Containment room

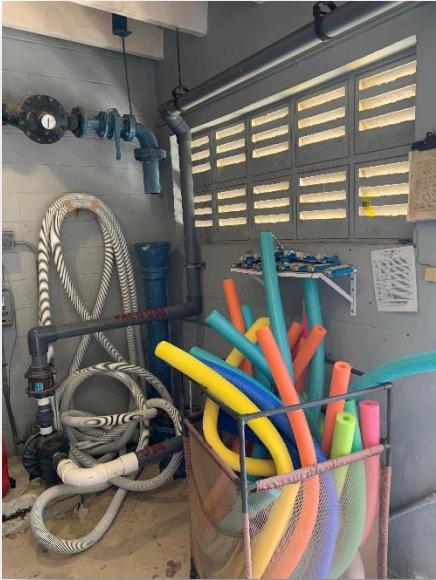
NW corner of storage room with vacuum pump and pool refill line

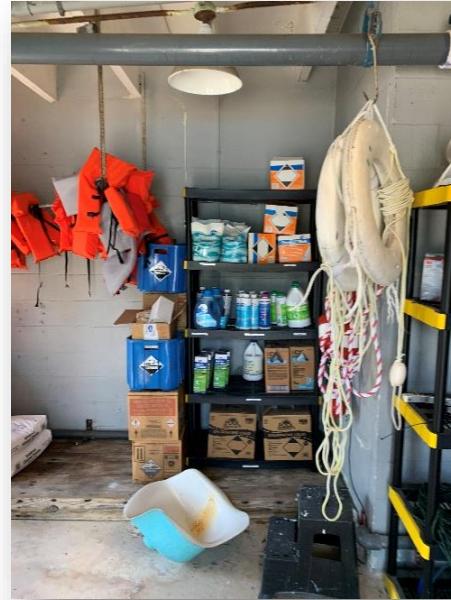
Chemical storage area

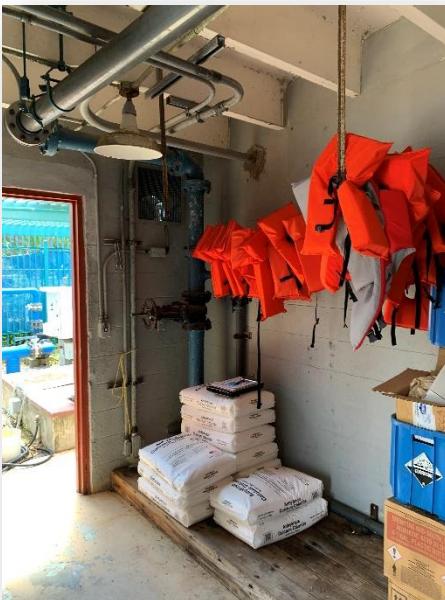
Storage room looking east through door to equipment yard

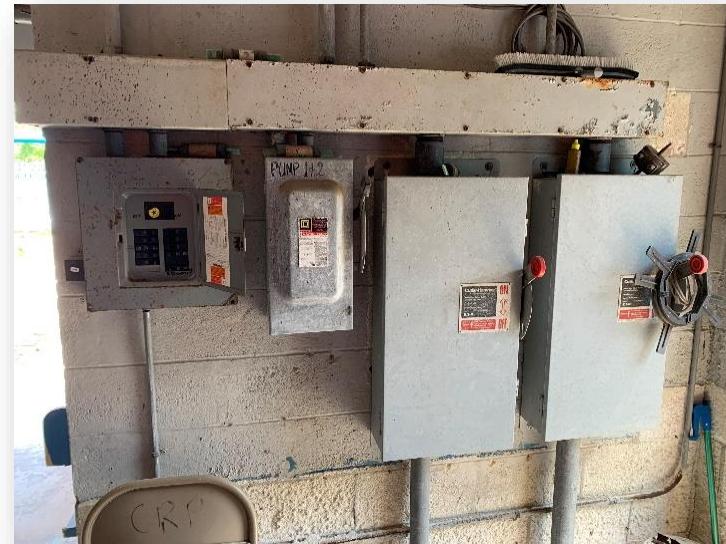
Electrical service—Two mains, pump controls and breaker

- **Pumps and MCC need upgrade**
- **Filters OK but media replacement needed**
- **Collector tank needs replacement**
- **Chemical feeds need upgrade**
- **Geothermal heaters need replacement**
- **All piping collection and returns replaced**

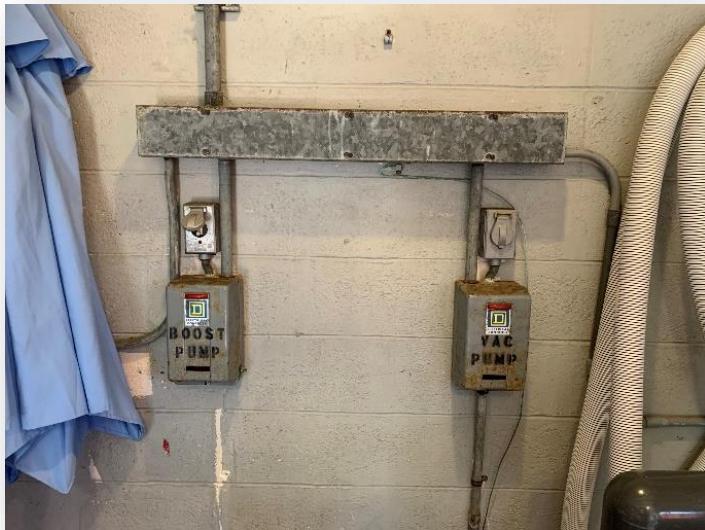
Booster pump and vacuum pump

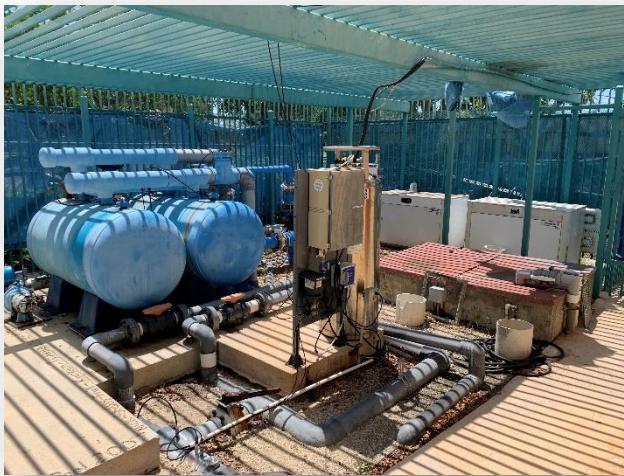
Equipment yard from NW corner—note chemical feed tubes along top

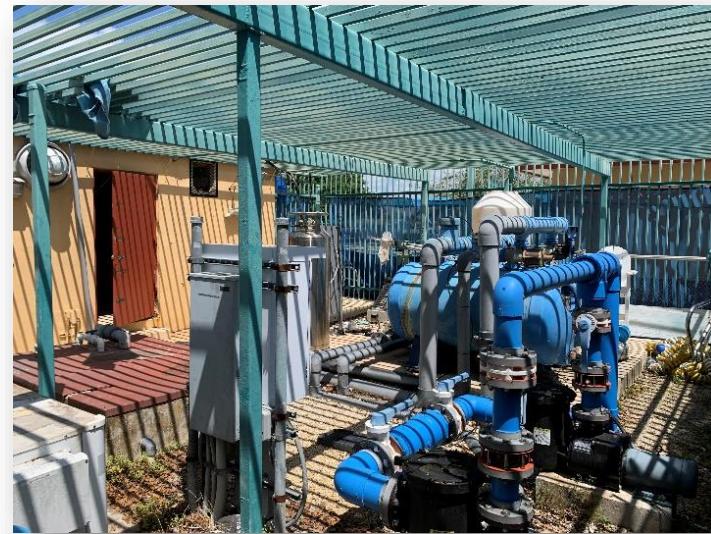
Equipment yard from SE corner

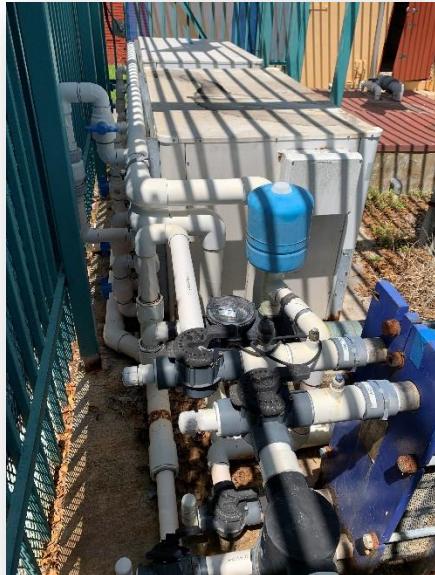
Geothermal heater units along with loop and well pumps

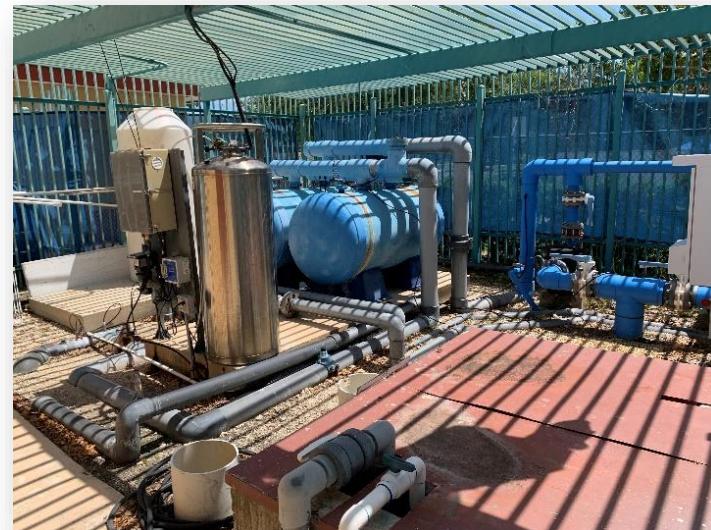
Equipment yard from SW corner

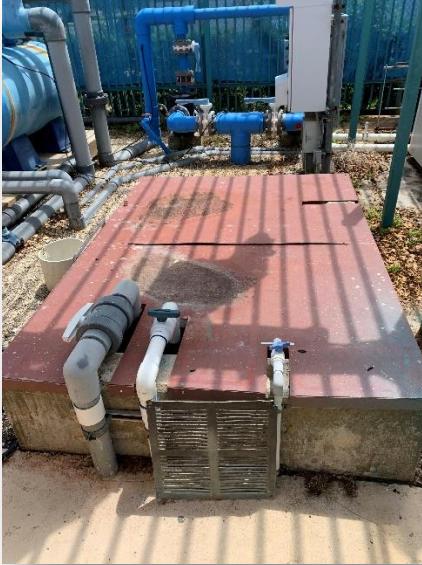
Collector tank showing infill lines and metal lid

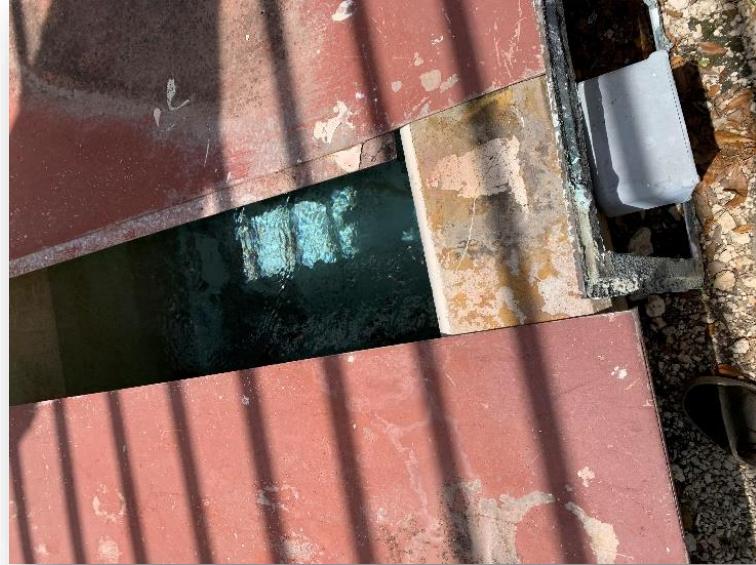
Collector tank with lid pulled back

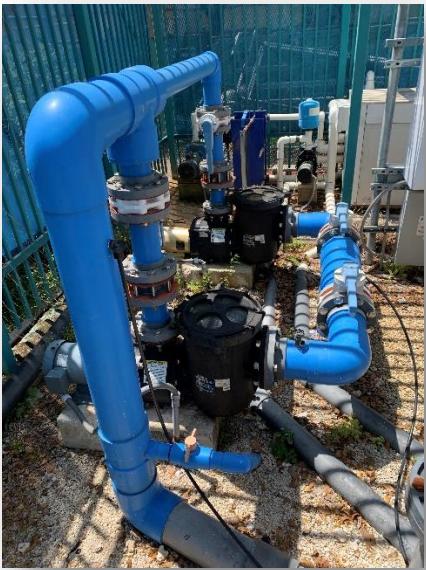
Pool Pumps with MCC, strainer baskets and piping

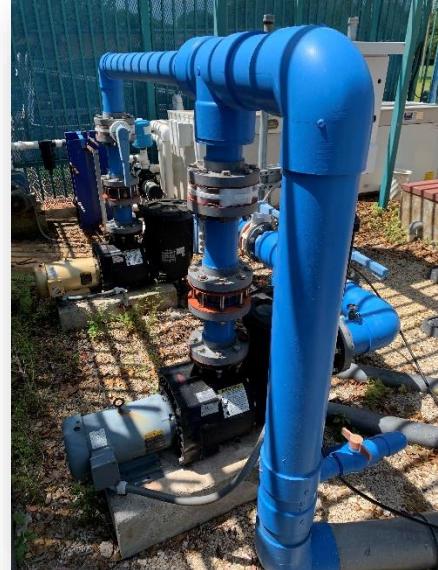
Pool pumps from back side

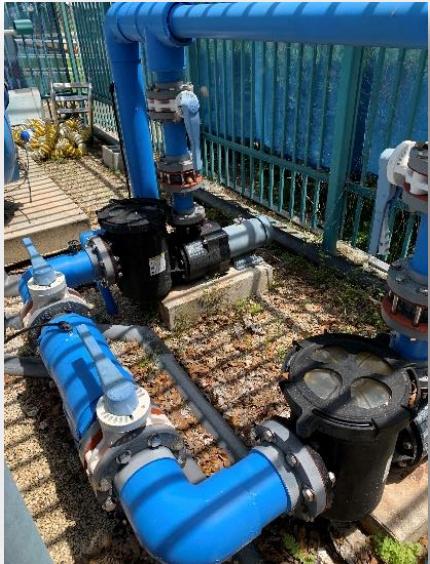
Pool pumps showing piping and control valves

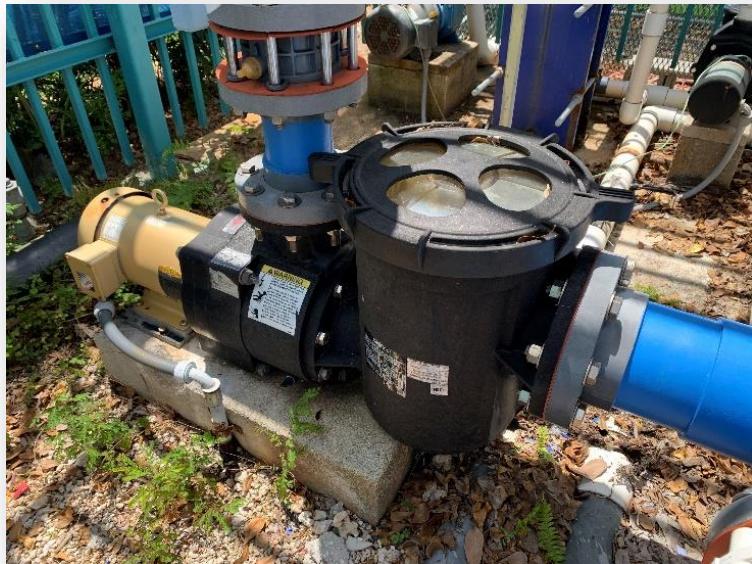
South pool and pump assembly

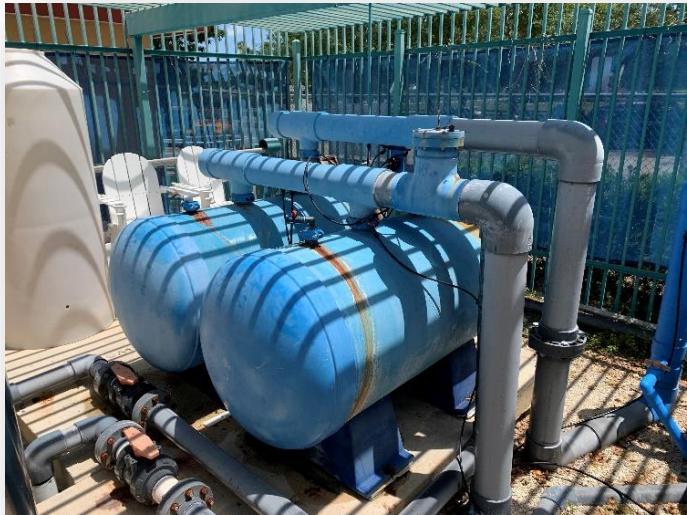
Horizontal sand filters with inflow and effluent lines

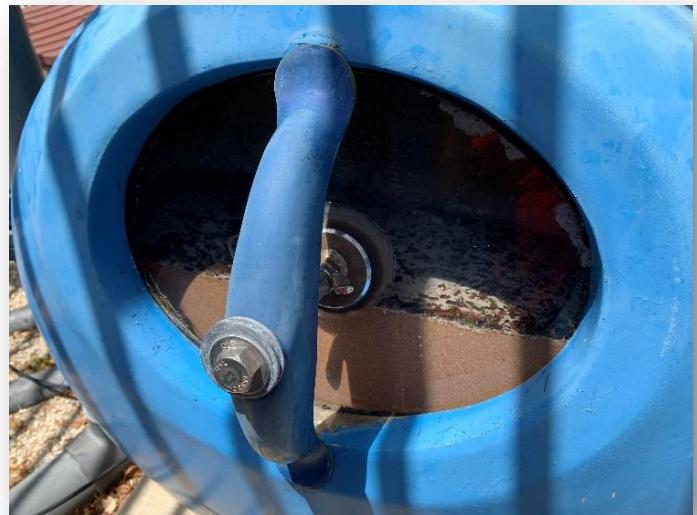
Filter window showing sand with debris

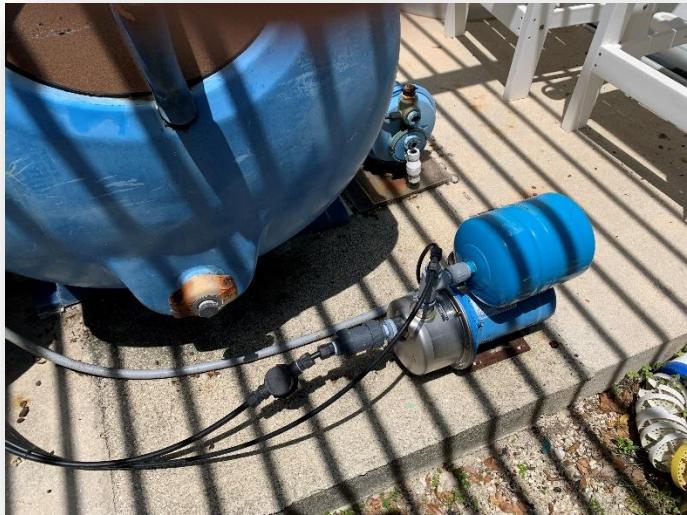
Filter booster pump

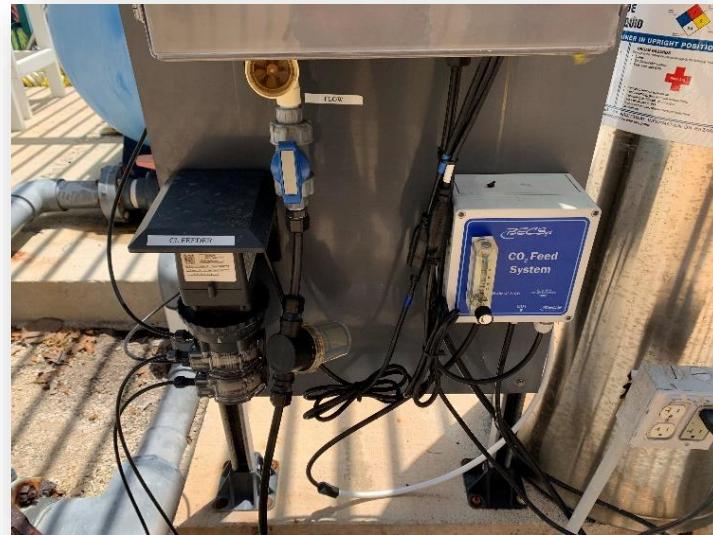
Chemical feed controls with chemical tubes.

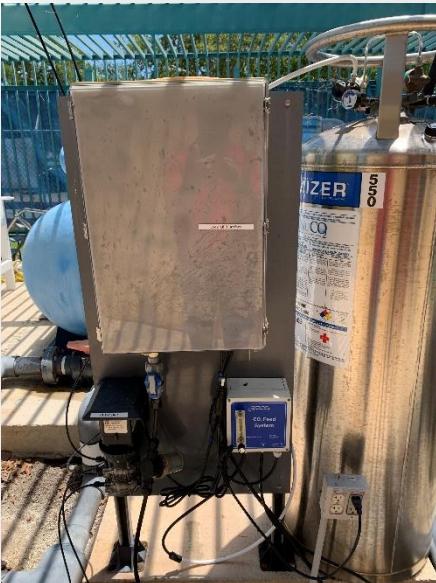
Chemical feed controls with CO2 tank

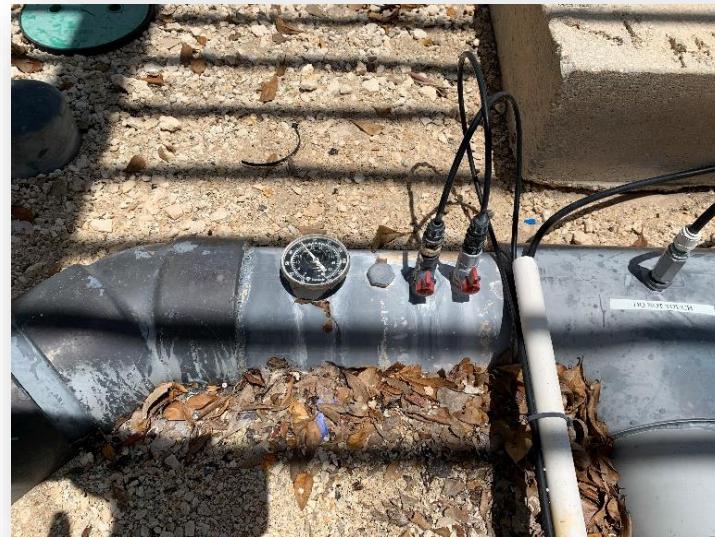
Chemical feed injection points

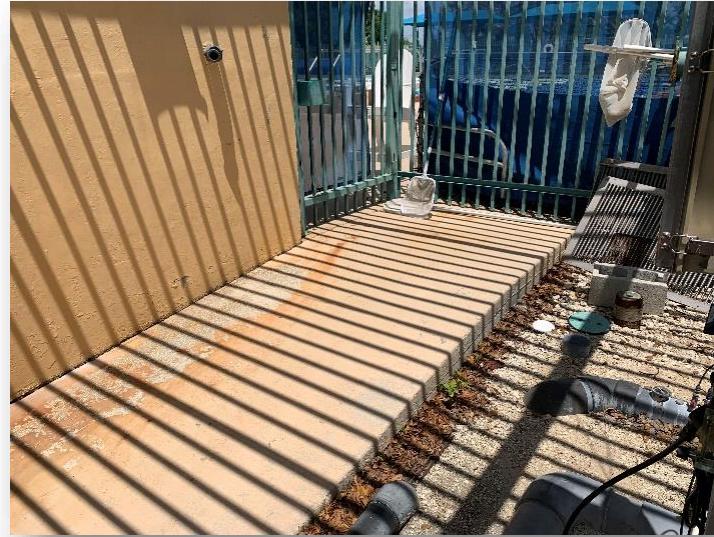
Concrete ramp from equipment yard up to pool deck

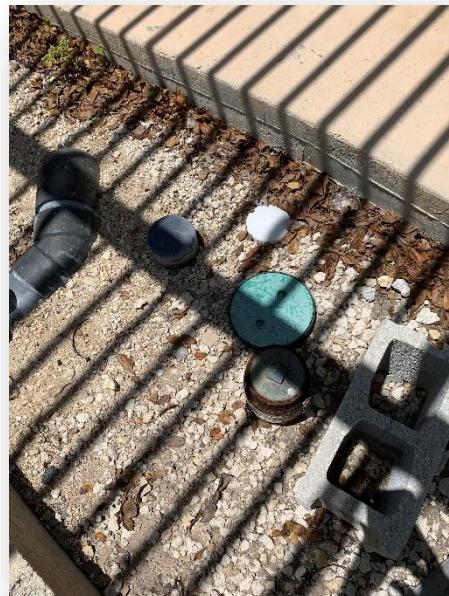
Miscellaneous valves and boxes in yard
